QUADRAPONG HARNESS ELEC. REV C

L.T.A.R.I.N.C. 18400 WINCHESTER BLVD.
 REV D LOS GATOS, CA. 95030
 408-374-2400
 SCH. QUADRA-PONG
 DRN: P.C.D. 12-10-73 APP. 12/14/73
 SHEET 1 OF 2

January 28, 1974

QUADRAPONG

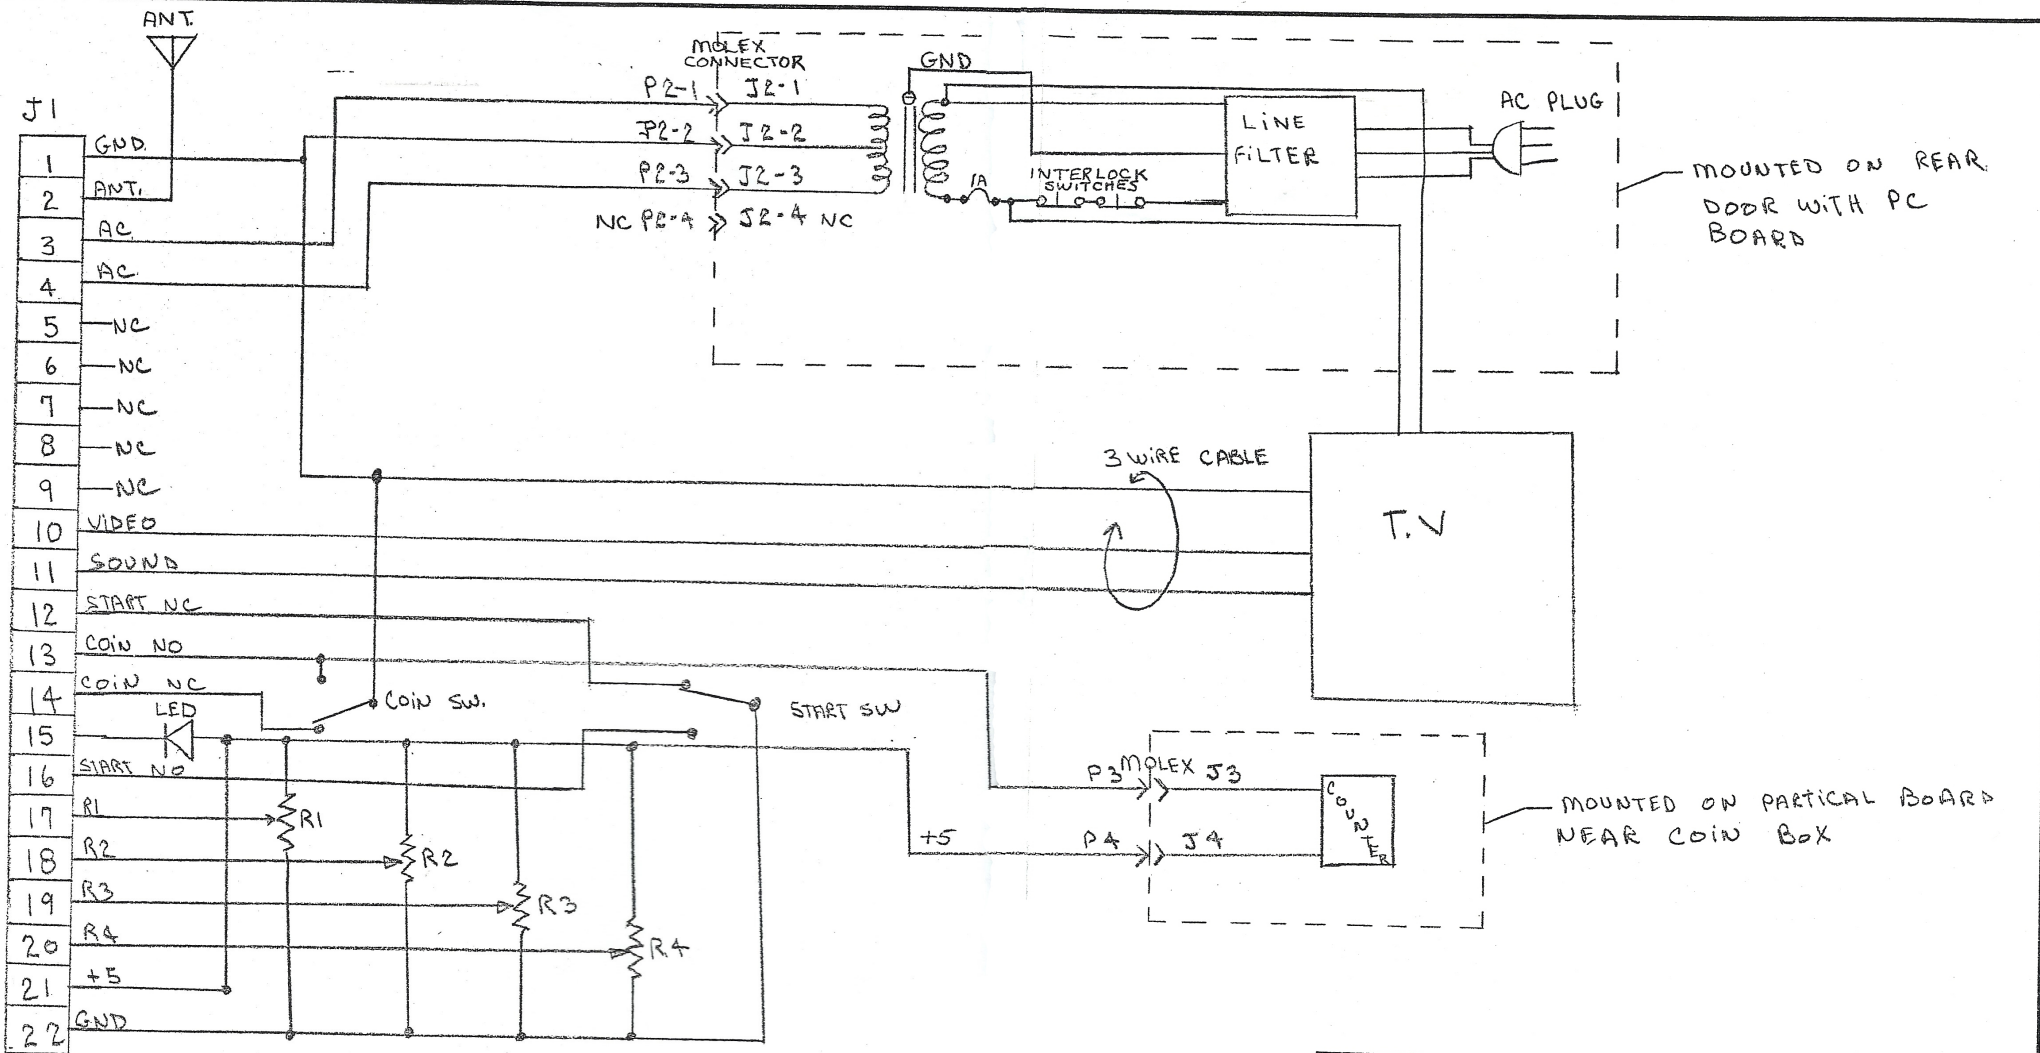
0m834

MOUNTED ON REAR DOOR WITH PC BOARD

MOUNTED ON PARTIAL BOARD NEAR COIN BOX
